## MACHINE SERVICE BULLETIN NO. 257

SUBJECT: Carriage Shift of LA-5 and  
LA-6 Machines

DATE: July 31, 1939

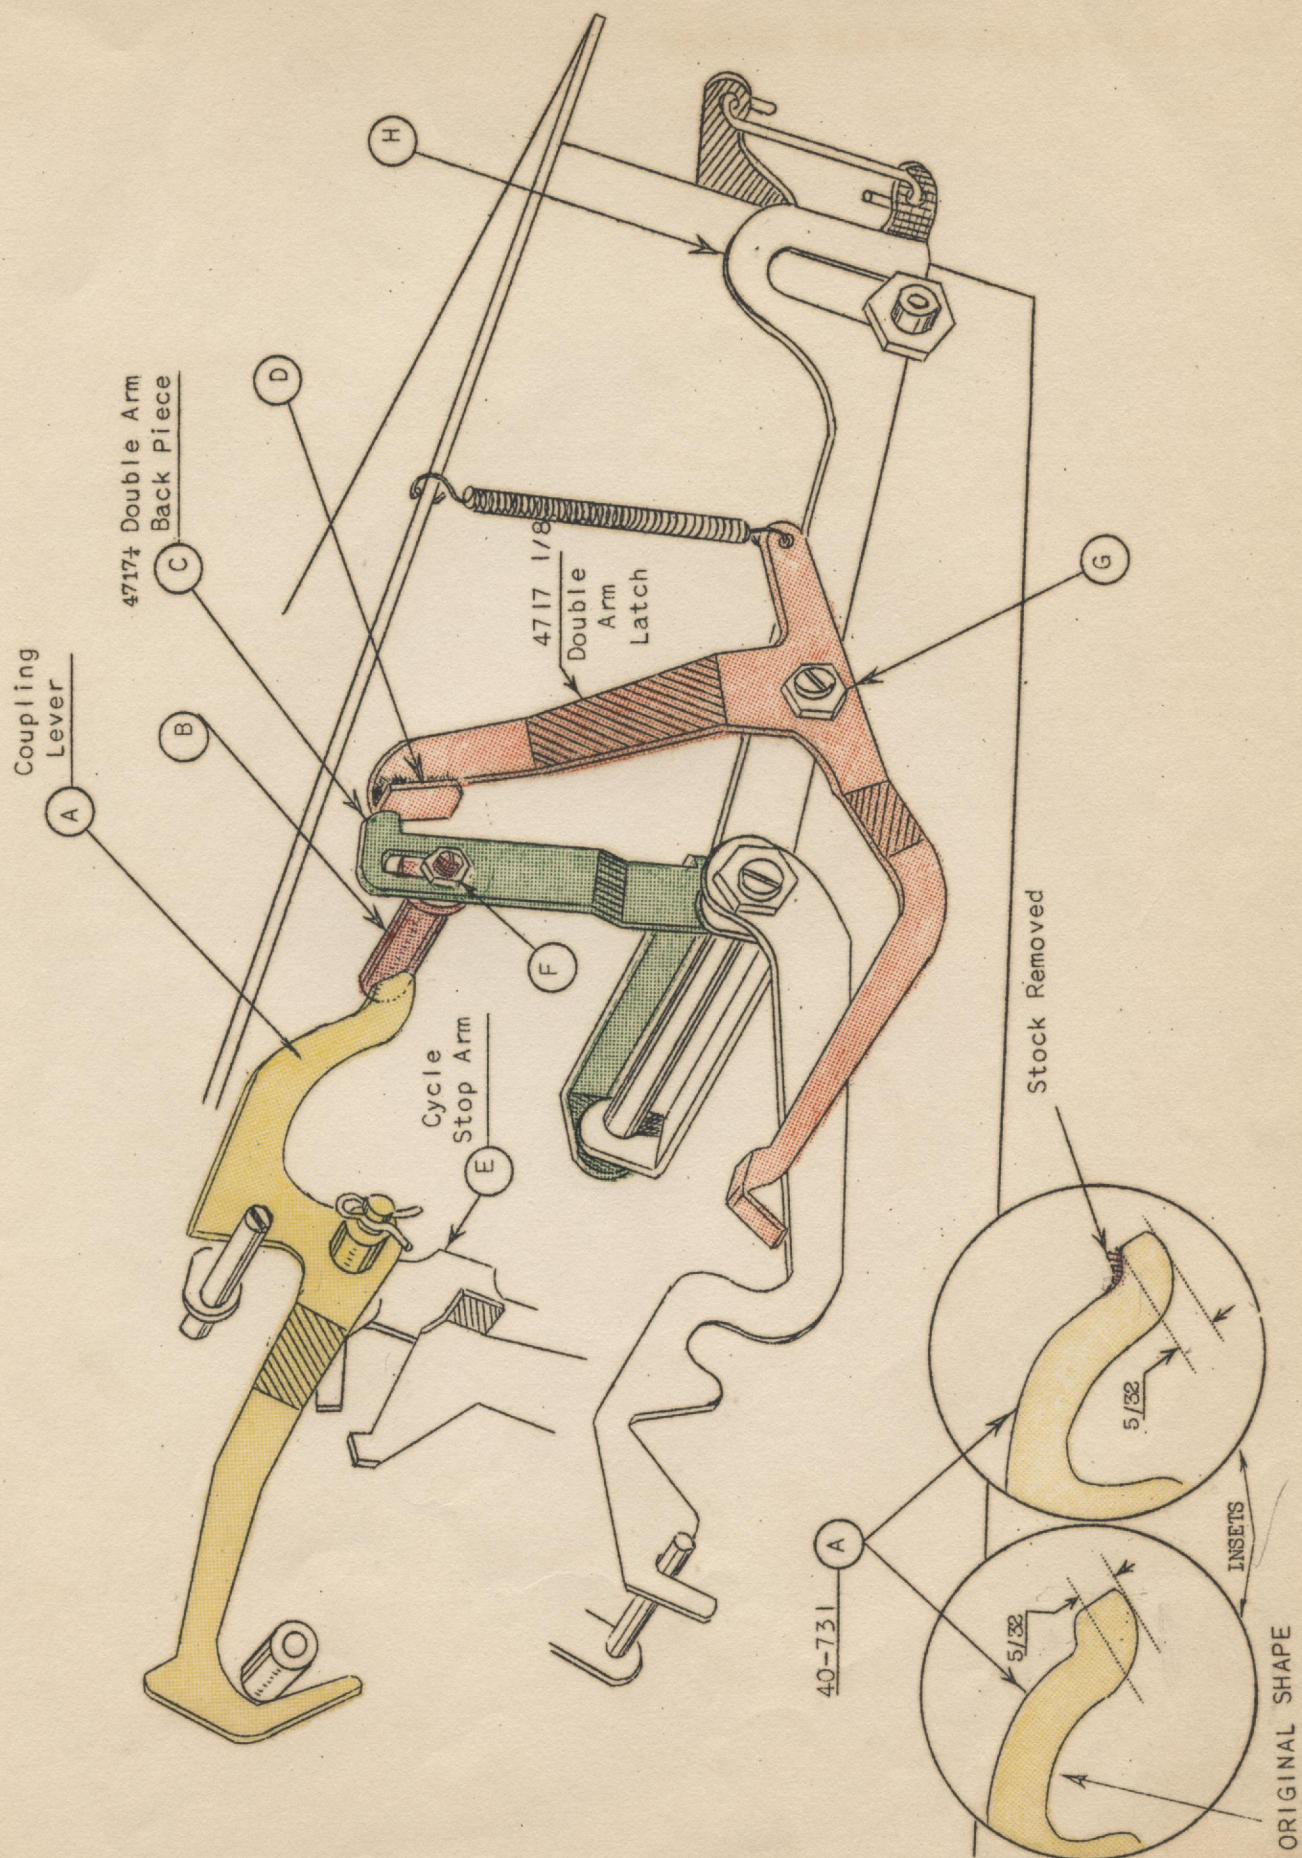
In order to obtain a satisfactory shift of the carriage on LA-5 and LA-6 model machines after all regular adjustments have been checked, servicemen have occasionally resorted to taking up on the clutch on the jack shaft until it failed to function as a slip clutch. To eliminate the need of such a practice, we suggest the removal of stock from the 40-731 coupling lever as illustrated on Plate 2 of this bulletin and the readjusting of the double arm latch 4717 1/8. Heretofore offset (D) was adjusted to (C) so that when the division lever was moved into operating position, (D) would latch under the step of (C) with as little excess clearance as possible and in order to insure the latching of (D) the 4717 1/8 was adjusted somewhat low. The natural result of this low adjustment was a loss of shift mechanism movement.

The journey of the cycle stop arm (E) to the bumper pad following an overcarry trip in minus, causes an idle movement of (A) in relation to (B), but following an over-carry trip in plus, (A) contacts and pushes (B) forward, causing a carriage shift.

To provide an upward adjustment of the 4717 1/8 by means of eccentric (G) without the possibility of it failing to latch under the step of (C) during the minus bumper stroke following an over-carry trip, stock could be removed from (A) as shown in the insets on Plate 2. The absence of this stock permits (C) to pivot rearward slightly more during the minus bumper stroke, thereby, allowing offset (D) to latch with (C) although the 4717 1/8 was adjusted higher than previously. Also, it is no longer necessary for (D) to latch under the step of (C) when the division lever is moved toward the carriage.

It will be interesting to note that after making this adjustment, (H) will be moved downward its entire distance before (A) starts to move under roller (B), thus proving that the grinding out of stock does not cause any loss of shift power.

After doing this it will be found that the slip clutch can be let out (friction reduced) considerably without retarding the carriage shift.

Roller (B) can be adjusted lower by loosening nut (F). However, its downward adjustment is limited due to interference with a stud on the machine stopping lever.
